## INSTALLATION GUIDE

# BMW & MINI heater flap repair

Cold (or hot) air from one side only? The fault is usually in the mixing-flap mechanism inside the heater box. This guide helps you find out which part is broken and walks you through fitting the right kit – through the footwell trim, without removing the dashboard.

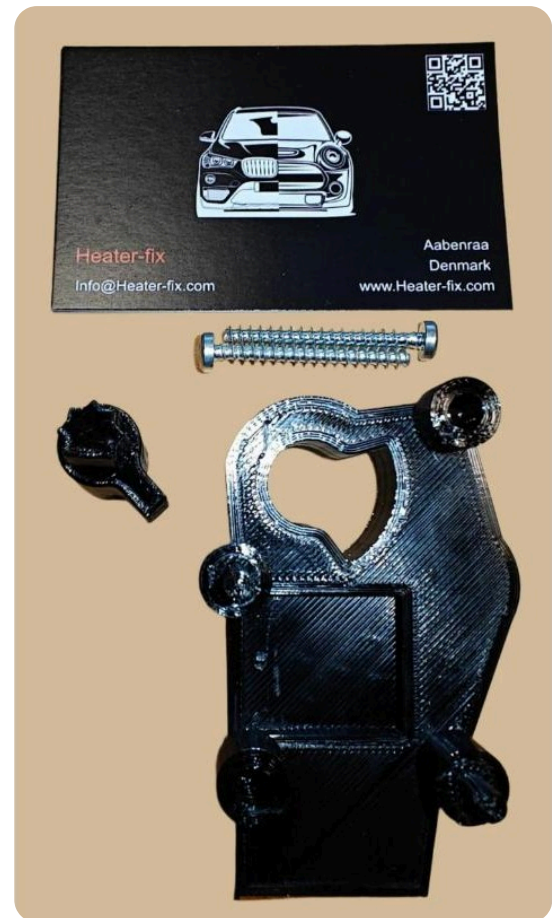
Heater Fix Kit: reinforced stops and longer screws.

- When the kit arrives, remove the actuator again.
- Fit the stops from the kit (parts are marked **L** and **R** for left and right side).
- Check that the shaft can turn and reaches the stops in both the hot and the cold position.

- Fit the actuator with the **longer screws** from the kit.
- Reconnect the electrical plug and refit the kick panel.

Reinforced stops and longer screws. Parts are marked L / R, so one kit covers either side.

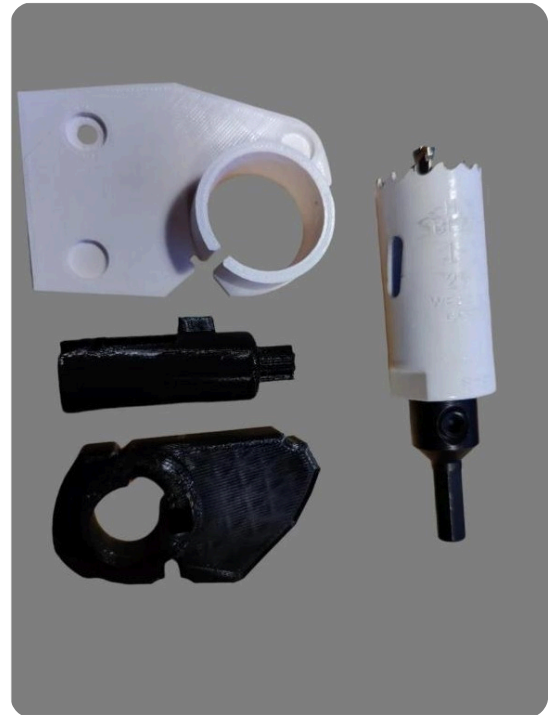
Broken Shaft Complete Repair Kit: drill guide, 29 mm hole saw, replacement shaft and stop insert.

- Fit the drill guide from the kit in its position on the heater box.
- Drill through the guide with the 29 mm hole saw **without** the centre drill bit.

- Optional: apply sealant or glue to the flap/shaft joint for extra stability.
- Push the new shaft in until it clicks and engages with the mixing flap.
- Turn the shaft by hand and check that the flap moves smoothly.
- Fit the stop insert, making sure the shaft is aligned correctly.

Drill guide, 29 mm hole saw, replacement shaft and stop insert – everything you need for the repair.
